# AAA Home Inspections LLC

## RE-INSPECTION of Completed REPAIRS

**Inspection Address:** 1234 Maple Ln  
Maryville TN

**Type of House:** Contemporary Rancher, with crawlspace.

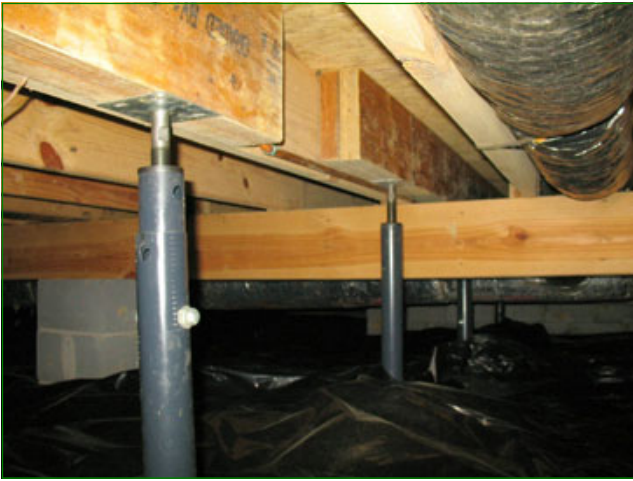
#1 **Item #1 and #2 are combined together:**

NEW PHOTO - Item #1 and #2 in the original report:  
Floor Sag Problem:

The owner has installed a group of doubled LVL (laminated veneer lumber) beams directly under the THREE LARGE WALLS that “define” the living room and kitchen. The beams are supported by adjustable floor jacks on a masonry base. The repair appears to be adequate.
